## 4 METHODS

### 4.1 Project Approach

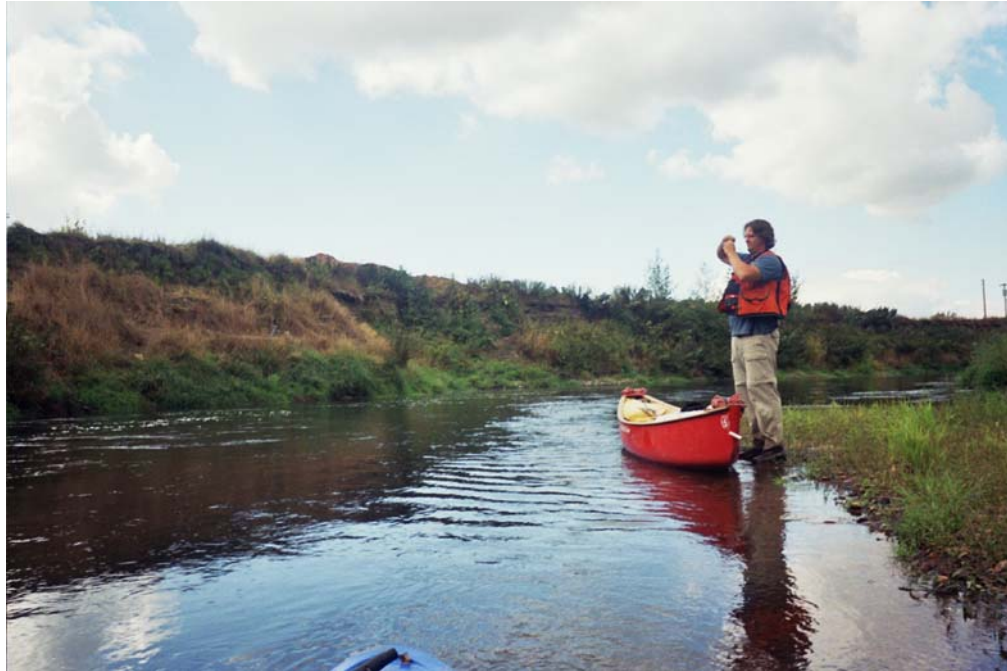
At each station, two measurements were recorded to calculate a rough estimate of bank height. First, a distance ( $d$ ) was taken across the channel to the opposite bank at about OHWM height. Second, the angle ( $a$ ) was measured using a handheld clinometer (Suunto model KB-4; Photo 4-1). Once completed, the bank height ( $x$ ) was estimated using the formula  $x = d * \tan a$ . This method did not account for bank slope. Due the difficulty of obtaining distance readings to the top of bank through thick vegetation, it was not possible to measure the distance to the top of the bank which would have allowed for a better estimate of bank height.

**Photo 4-1. Estimation of bank height using clinometer.**

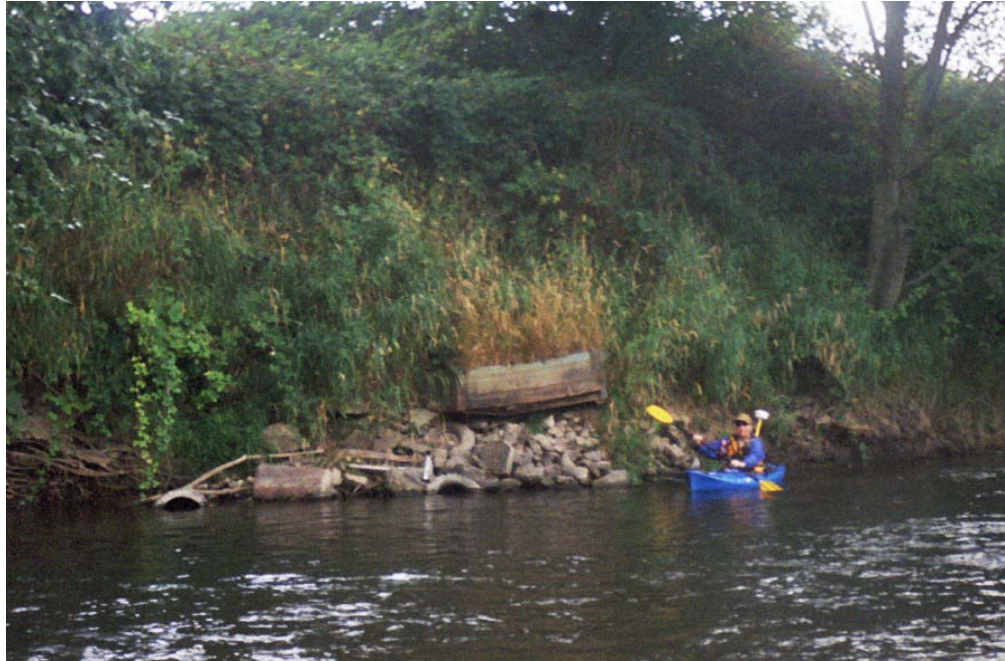
A visual estimate of the percentage of bank armoring and dominant armor type along each 300 m reach was recorded. The dominant armor types were: riprap, sheetpile, bulkhead, and other. Examples of other types of armor included tires, broken concrete, bricks, and trash. Separate estimates were made for each bank based on the 300 m immediately upstream from the recording station. Additionally, separate DGPS location data were recorded to document the presence of unusual structures functioning as bank armor, such as tires or refuse (Photo 4-2). Due to obscuration of bank armor in numerous locations by sediment deposits and vegetation, these are conservative estimates and may underestimate the full extent of bank armor.

**Photo 4-2. Concrete, tire, and other debris on a bank of the Lower Green River.**

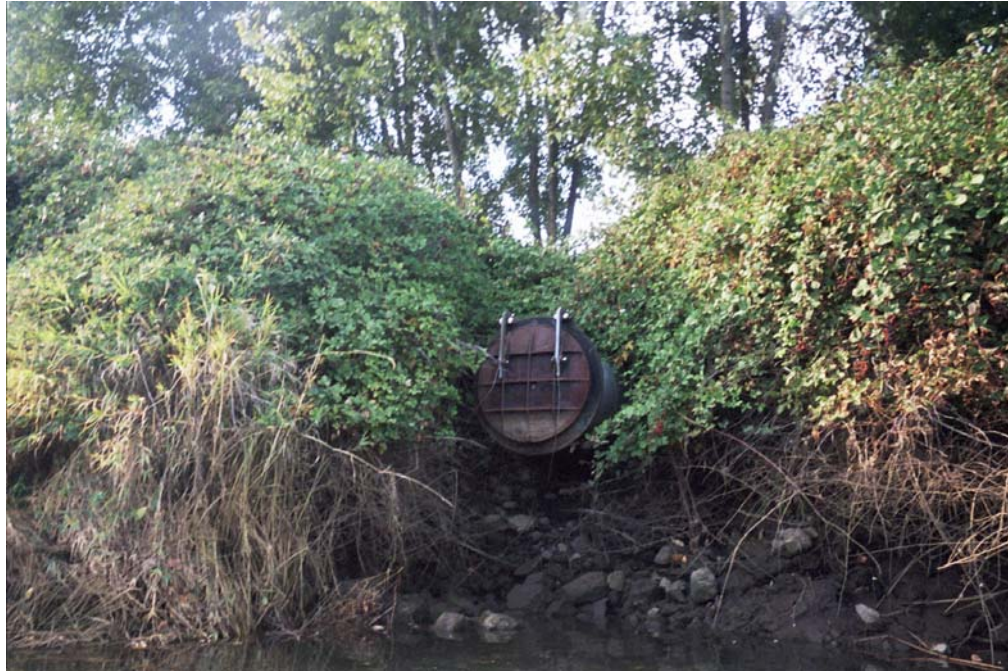
The locations of all outfalls exceeding 30 cm in diameter were collected from the approximate edge of water. The parameters recorded included the diameter of the outfall and the presence or absence of a flapgate, a structure that prevents flow from the river from entering the outfall structure (Photo 4-4) during floods.

**Photo 4-4. Outfall with flapgate in a bank of the Lower Green River.**

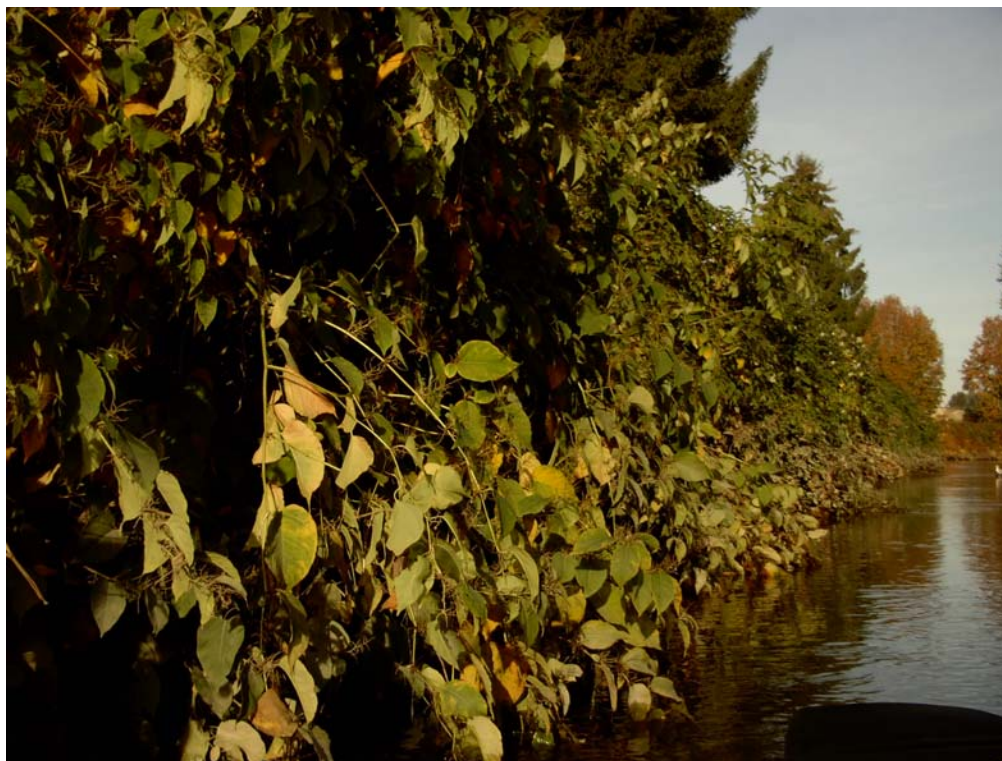
Observations were recorded on the locations of two invasive vegetation species: Japanese knotweed (*Polygonum cuspidatum*) and purple loosestrife (*Lythrum salicaria* L.) in the study area (Photo 4-5 and 4-6, respectively). DGPS locations were recorded where a patch of either species was noted in the area from the edge of water to the top of bank. Positions were taken at the approximate longitudinal center of each patch from the edge of water. The length of each patch along the shoreline was also estimated.

**Photo 4-5. Japanese knotweed lining the bank of the Lower Green River.**

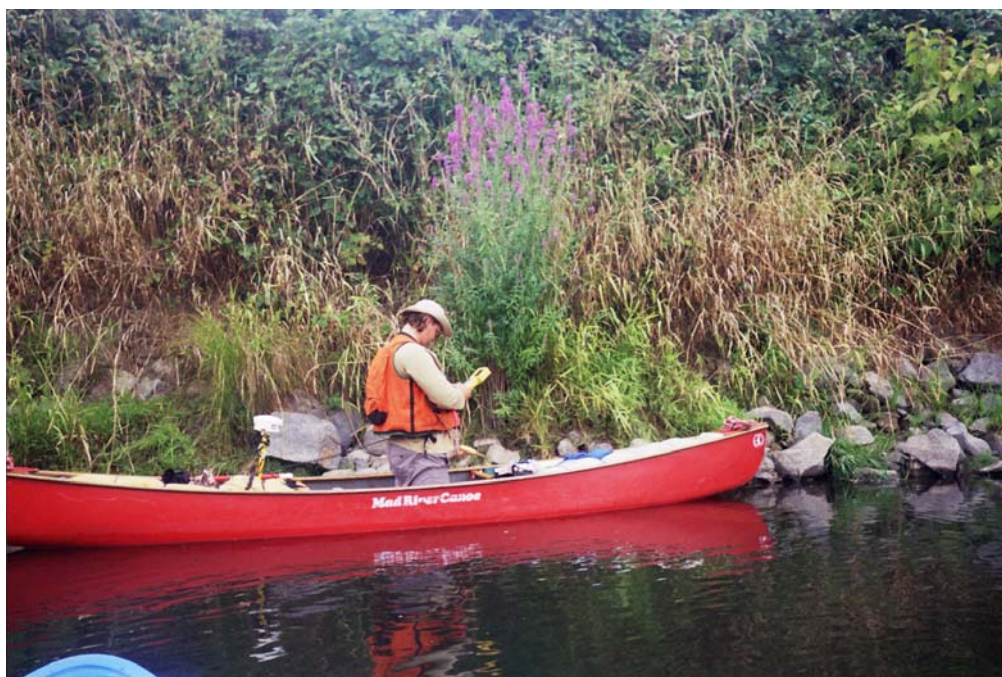
**Photo 4-6. Purple loosestrife in the survey area (tall flowering plant directly behind field crew member).**
